**NOTICE OF DISCLOSURE OF EXPERT AND
FILING OF RULE 26(A)(2)(B) REPORT OF SCOTT L. TURNER**

Expert Report of Scott L. Turner

Case Caption: Bryan Stanley vs. Old Dominion Freight Line, Inc., and Isaac Stovall

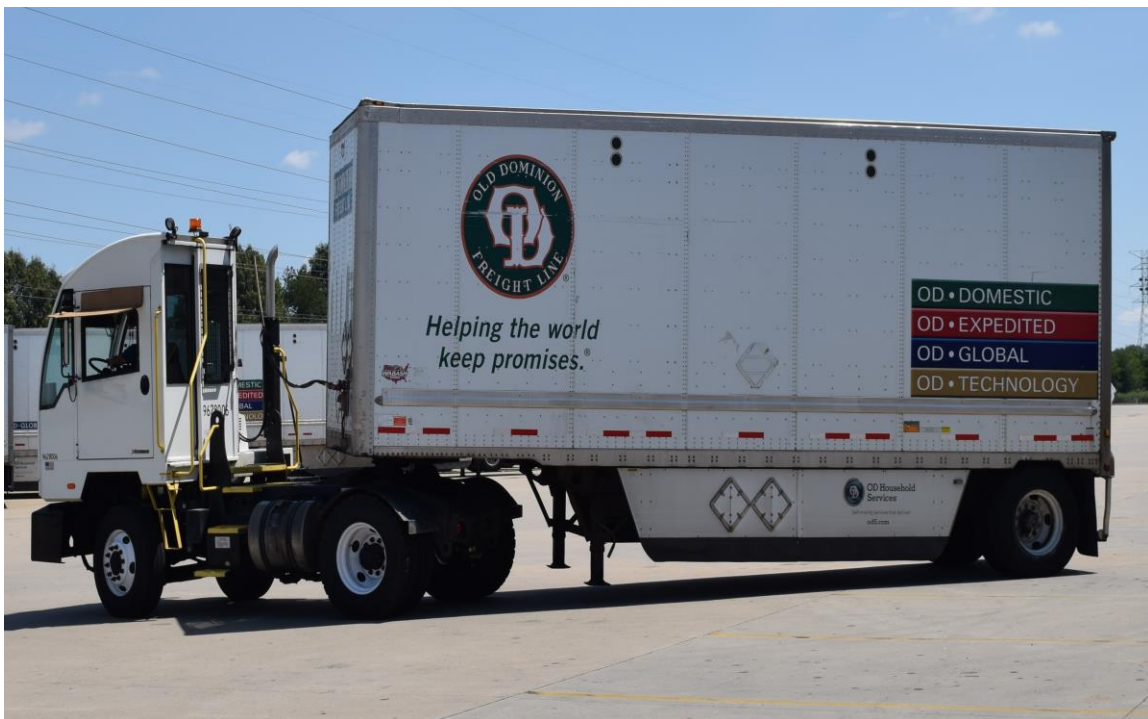
In addition, Stovall failed to G.O.A.L. (GOAL) or *Get Out and Look* method and requirement before engaging and committing his Switcher coupled to the pup CMV semi-trailer in rearward backing up movement. Image #1 is representative of the CMV combination which Stovall was operating on the day and time of the subject pedestrian crushing incident:

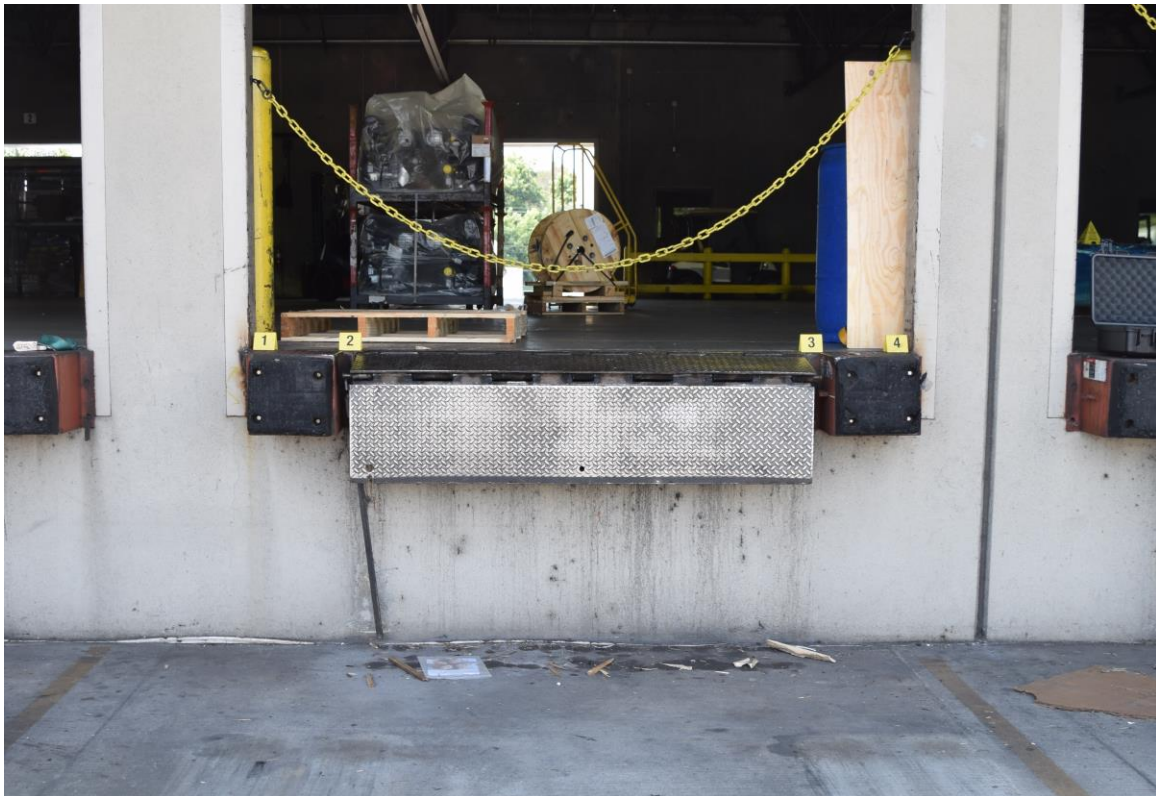
Image #2 above is of the loading dock where the subject pedestrian crushing incident occurred. The warehouse floor level of this loading dock is approximately 48 inches above the surface of the lot. Those areas labeled as “1” and “4” are the outside edges of

the aforementioned black rubber bumper frames which will be described in detail hereunder.

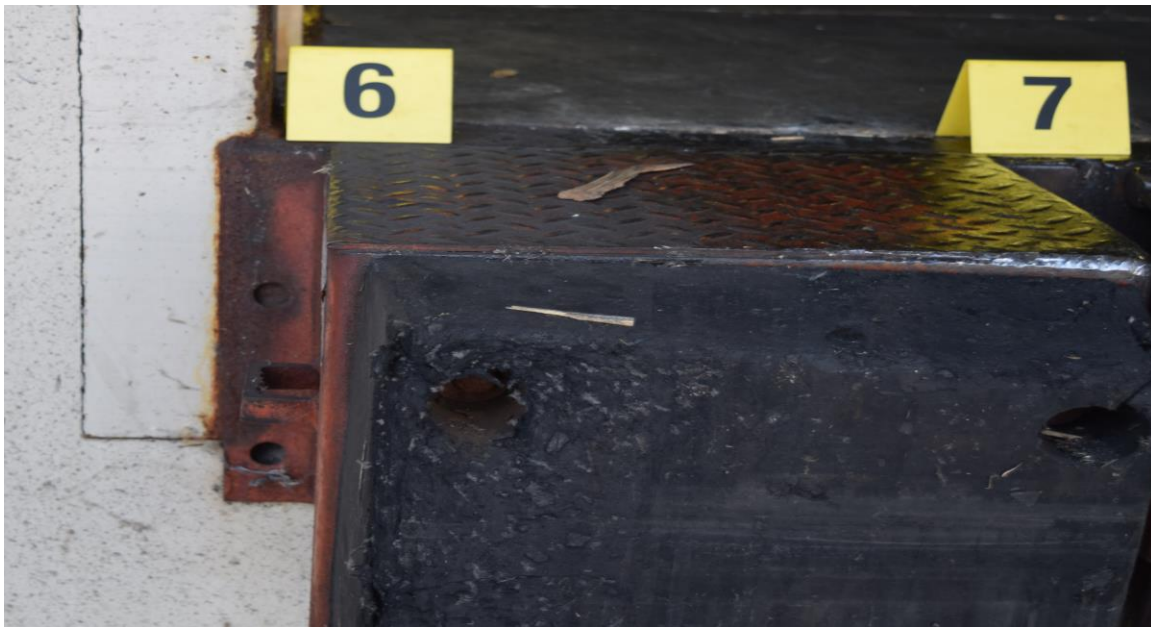
Image #3 reflects a loading dock at the Old Dominion facility which is not the loading dock where the subject pedestrian crushing incident occurred. However, it is of the same design and approximately the same dimensions as the subject loading dock. The area labeled “6” is at the left end of the loading dock/rubber bumpers and has not received the welding repairs at the time the photograph was taken. As such, Image #4 is of the left end of the loading dock where the subject pedestrian crushing incident occurred, and the repair welds are visible below the “1” label.
